# Vertech Case Study

## Corrosion Under Insulation Inspection

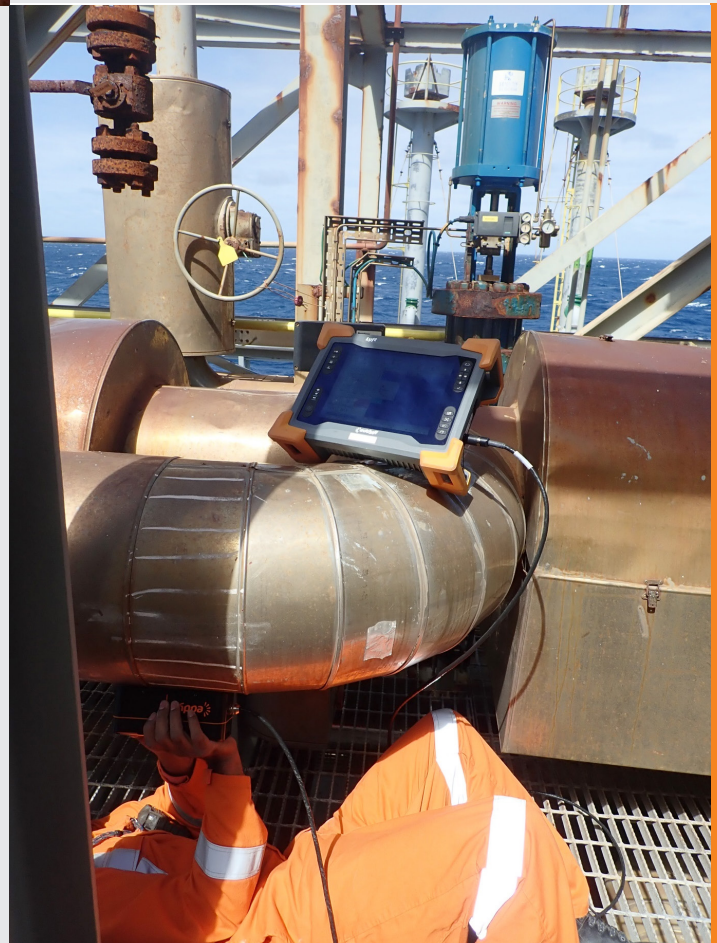
The piping targeted for PEC screening was selected by the MODEC Asset Integrity Manager and the Vertech Offshore Team Leaders. Using a combined local knowledge of the plant and relevant damage mechanisms, the first survey was a success with areas of piping being earmarked for further insulation stripping and visual/ultrasonic inspection. Due to the success for the first survey, two more surveys were planned and carried out. The second survey scope was expanded to include pressure vessels. As with the first survey, areas of CUI were found after the insulation system was stripped. Due to the ongoing CUI problem, the operator has now begun a systematic replacement of the old insulation system with a newer system allowing a greater reduction in the occurrence of CUI. This allows for a more targeted inspection and fabric maintenance program.
