**Vertech
Case Study
GWA Flare Tip Replacement**

The Goodwyn Alpha Life Extension (GLE) project is an ongoing project to extend the life of the Goodwyn platform, its associated wells, risers and subsea infrastructure until its end of economic life. The object of the project is to extend design life by a further 12-18 years from 2025 to realise the production of existing reservoirs and the upcoming Greater Western Flank development.

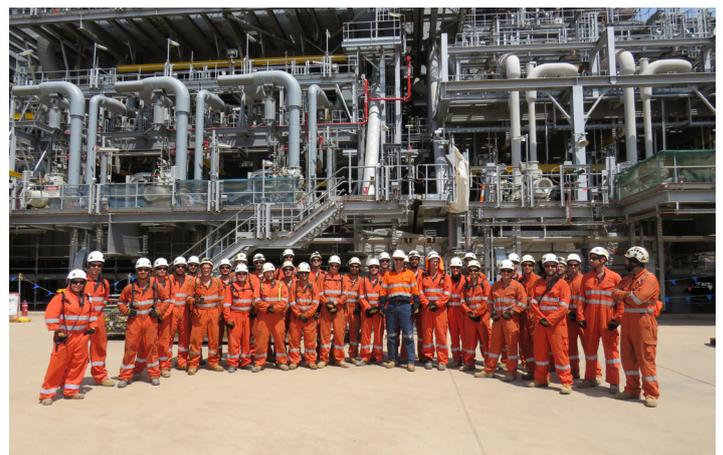
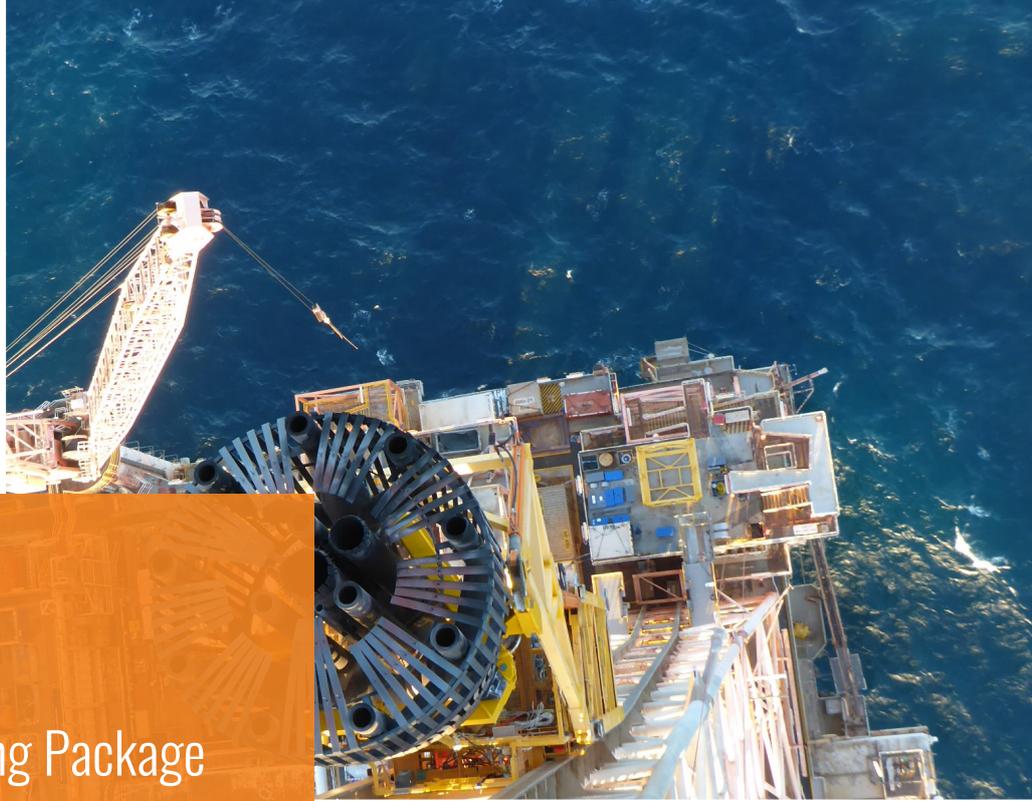
HP/LP Flare Tip Handling Package (FTHP)

Specifically built for the GWA Flare Tower, the package was refurbished and trialled at King Bay Supply Base on a Mock-up Flare Tower.

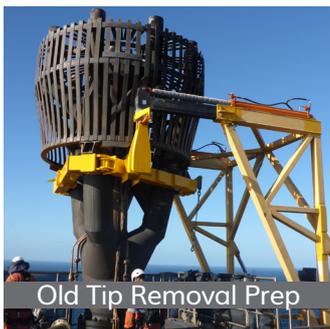
Old Tip Removal Prep

On arrival the team commissioned the Flare Tip Handling Package and function tested the FTHP and all other Vertech equipment. This was followed by a 'make safe' campaign, removing potential dropped objects.

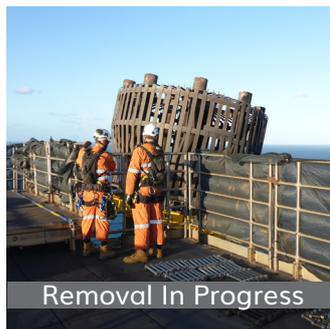
Removal In Progress

The FTHP was driven to the top of the flare where heavy rigging and lifting equipment was used by our multi-disciplined rope access team to remove the flare tip. The operation was carried out a second time to install a new flare tip and perform all the tensioning and torquing requirements.

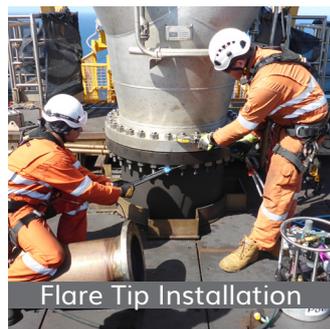
Flare Tip Installation

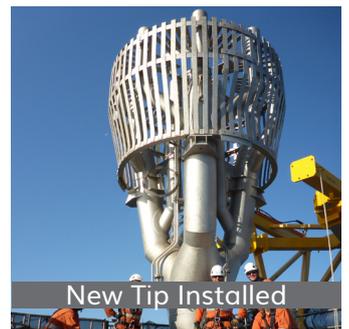
New Tip Installed
